SMITHSONIAN INSTITUTION
BUREAU OF AMERICAN ETHNOLOGY
BULLETIN 121

ARCHEOLOGICAL REMAINS IN THE WHITEWATER DISTRICT EASTERN ARIZONA

PART I. HOUSE TYPES

By FRANK H. H. ROBERTS, JR.

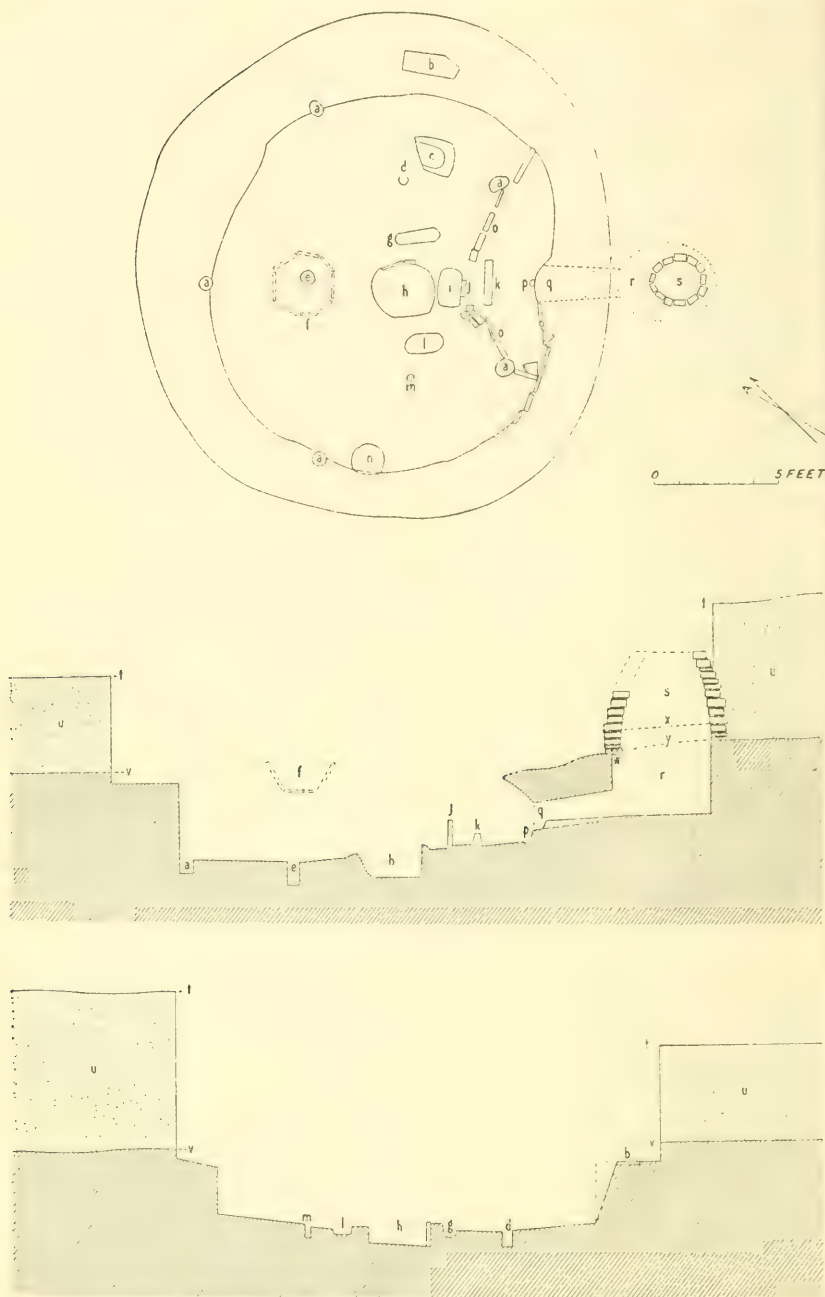
FIGURE 36.—Structure 15. *a*, holes for support posts; *b*, stone embedded in bench top; *c*, metate on floor; *d*, small storage hole; *e*, sipapu; *f*, fire pit; *g*, basin in floor; *h*, fire pit; *i*, ash pit; *j*, deflector; *k*, step and ladder brace; *l*, basin in floor; *m*, storage hole in floor; *n*, storage basin; *o*, compartment wall; *p*, hole for post to brace cover stone; *q*, ventilator opening; *r*, base of ventilator shaft; *s*, ventilator opening on ground; *t*, present surface; *u*, sand accumulation; *v*, original surface; *w*, wooden support for masonry; *x*, floor in granary; *y*, surface of accumulated material in shaft.

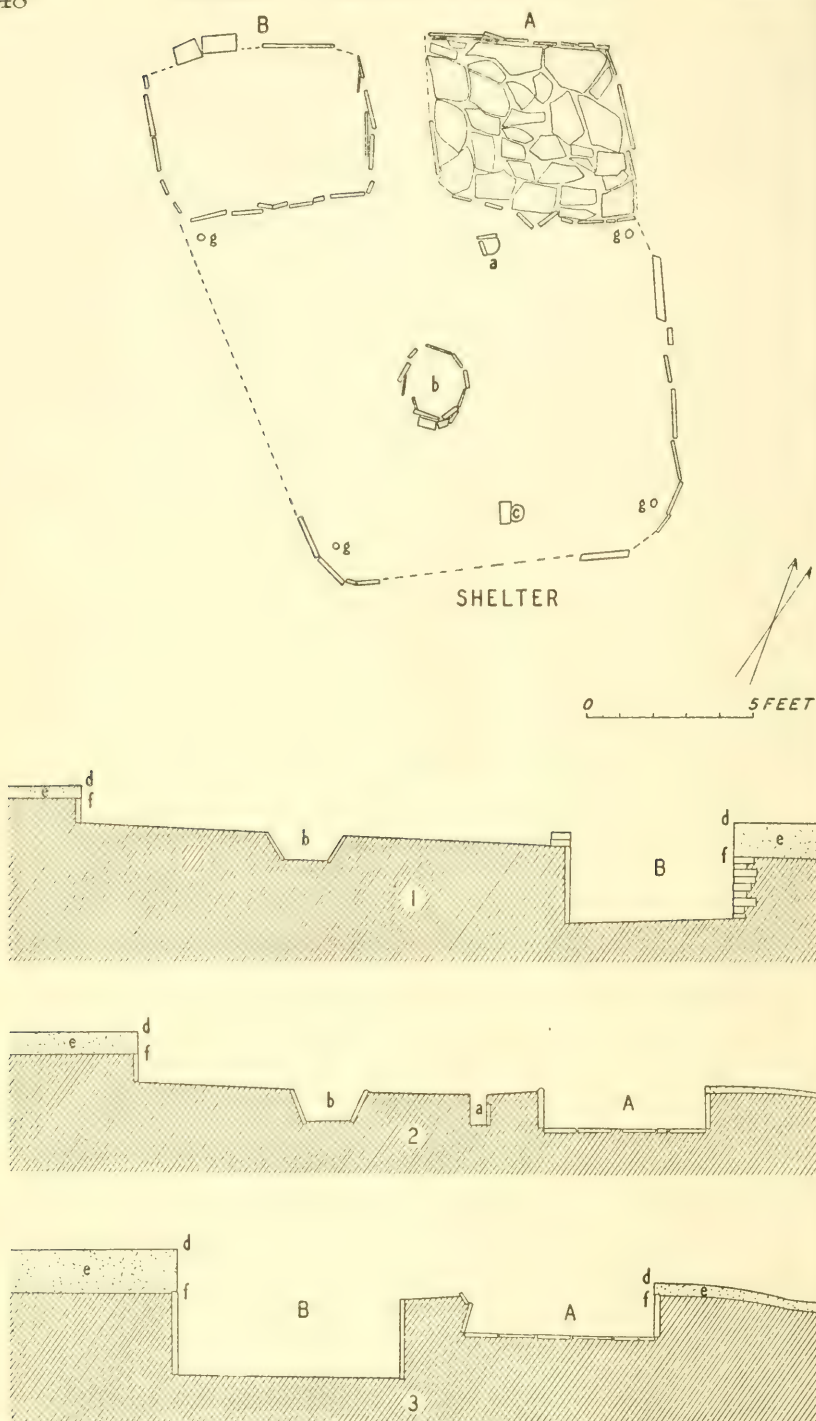
FIGURE 38.—Granaries A and B and shelter in No. 15 group. *a*, hole for support post; *b*, fire pit; *c*, hole for support post; *d*, present surface; *e*, sand fill; *f*, original surface; *g*, holes for corner supports for arbor.

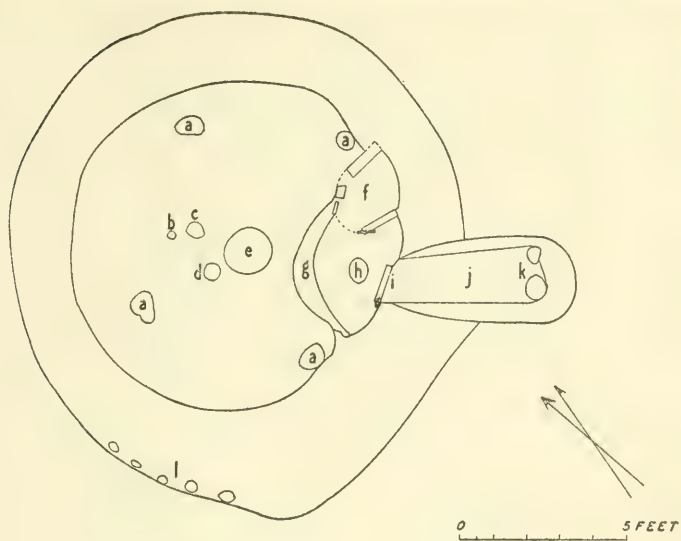
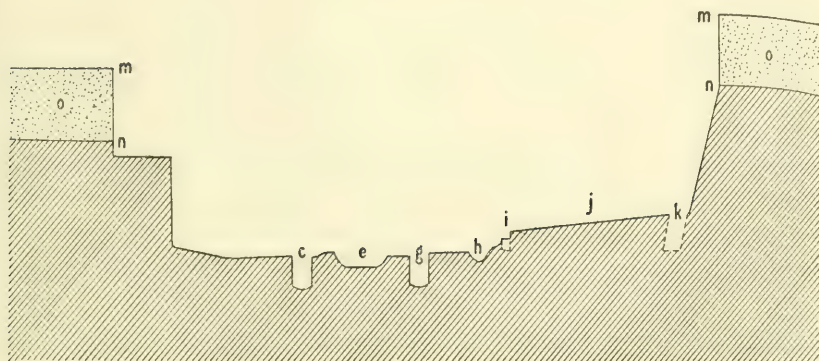
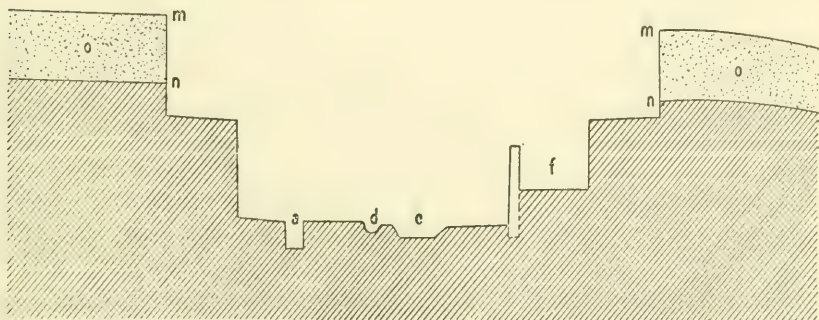
FIGURE 40.—Structure 10. *a*, holes for main roof supports; *b*, small storage hole; *c*, sipapu; *d*, pot rest; *e*, fire pit; *f*, storage bin; *g*, groove for compartment wall; *h*, basin in floor; *i*, sill in passage opening; *j*, passage; *k*, holes for ladder poles; *l*, placements for side poles; *m*, present surface; *n*, old surface; *o*, sand fill.

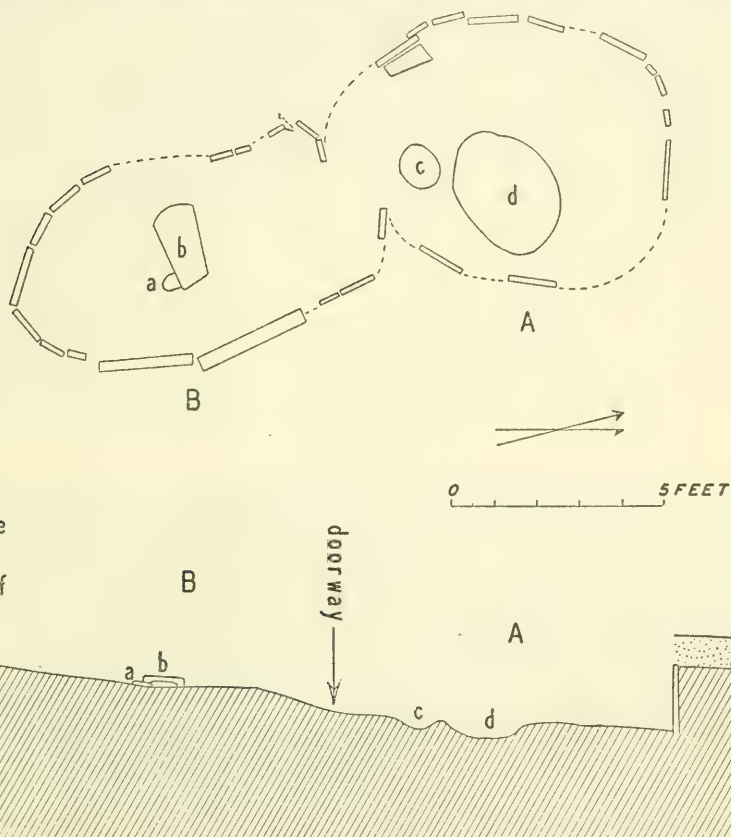
FIGURE 41.—Granaries A and B of the No. 16 group. *a*, mano or hand milling stone; *b*, metate stone; *c*, fire pit; *d*, storage basin; *e*, present surface; *f*, original ground level.

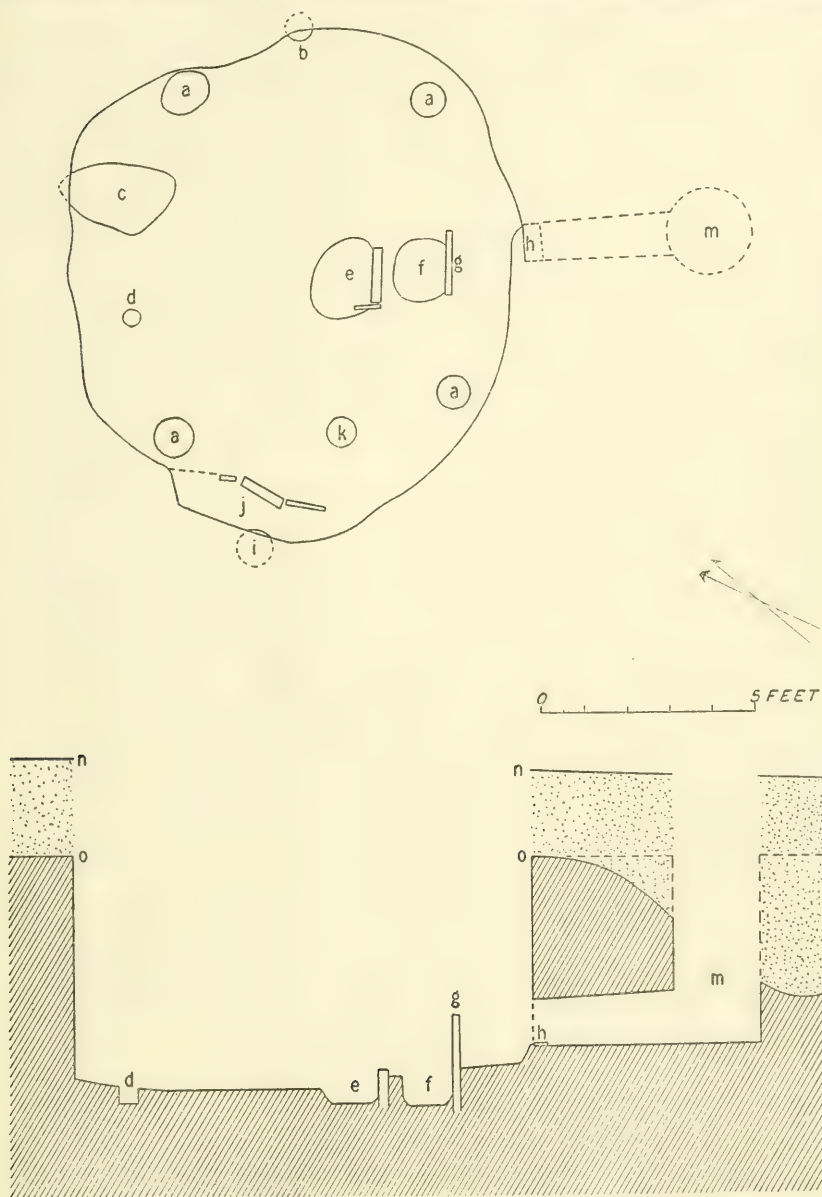
FIGURE 42.—Structure 17. *a*, holes for support posts; *b*, subwall pocket; *c*, storage pit; *d*, sipapu; *e*, fire pit; *f*, basin for ashes and ladder; *g*, deflector; *h*, sill in ventilator opening; *i*, subwall pocket; *j*, storage bin; *k*, pot rest; *m*, ventilator shaft; *n*, present ground level; *o*, original surface.

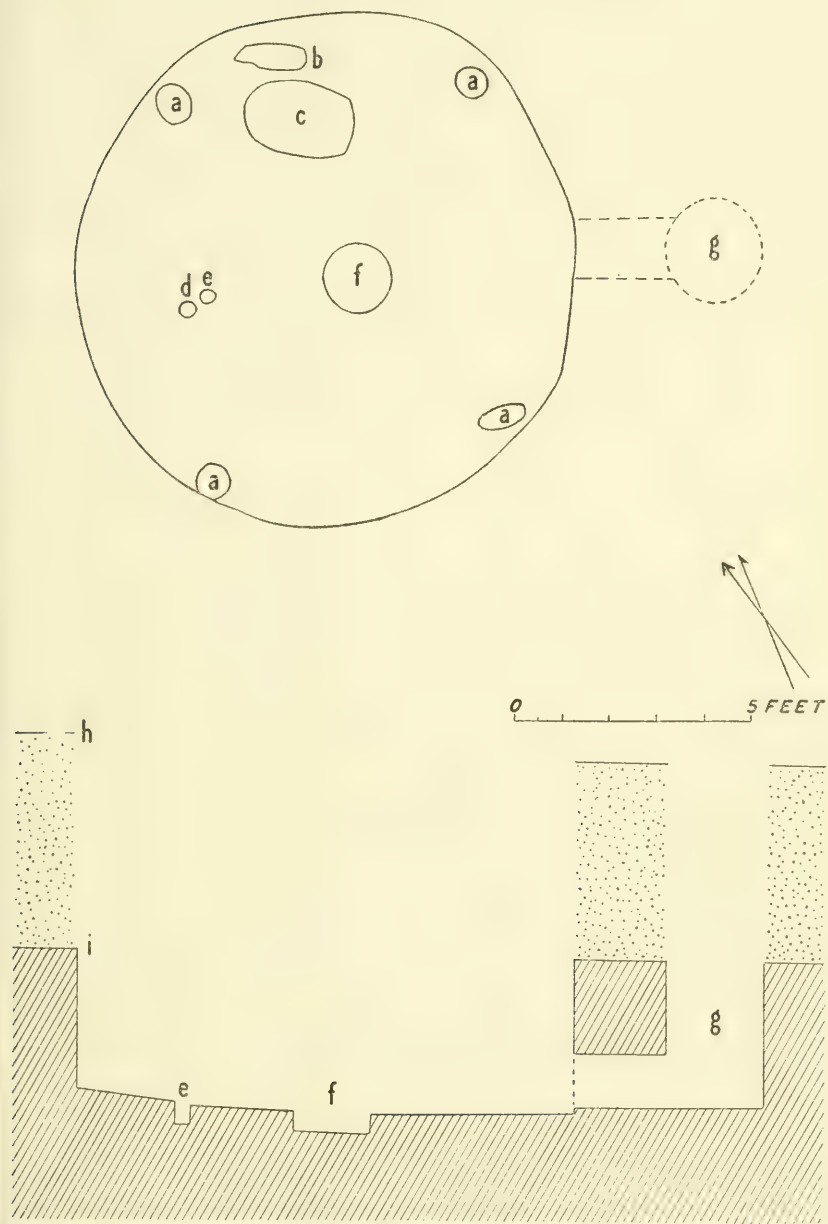
FIGURE 43.—Structure 18. *a*, holes for roof supports; *b*, storage pit in floor; *c*, storage basin; *d* and *e*, sipapus; *f*, fire pit; *g*, ventilator shaft; *h*, present surface; *i*, old ground level.

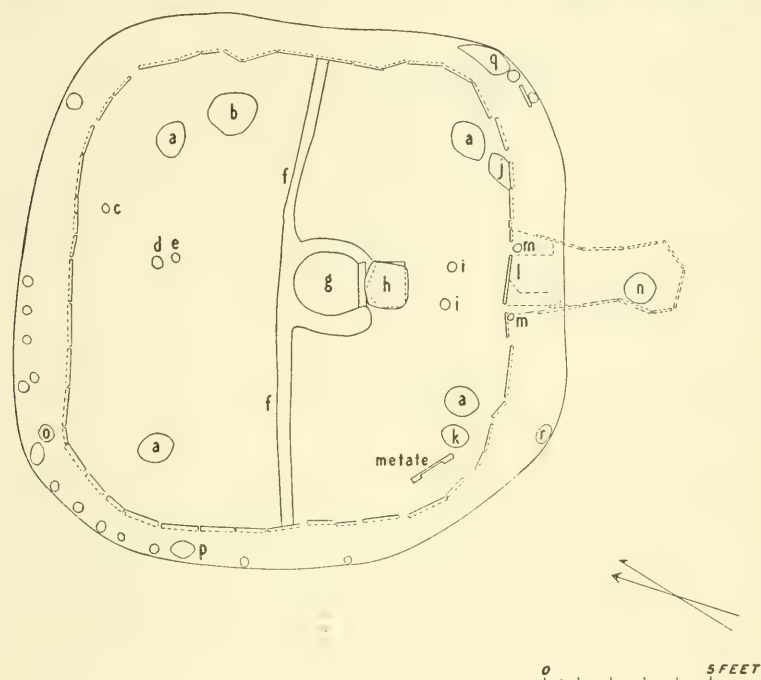
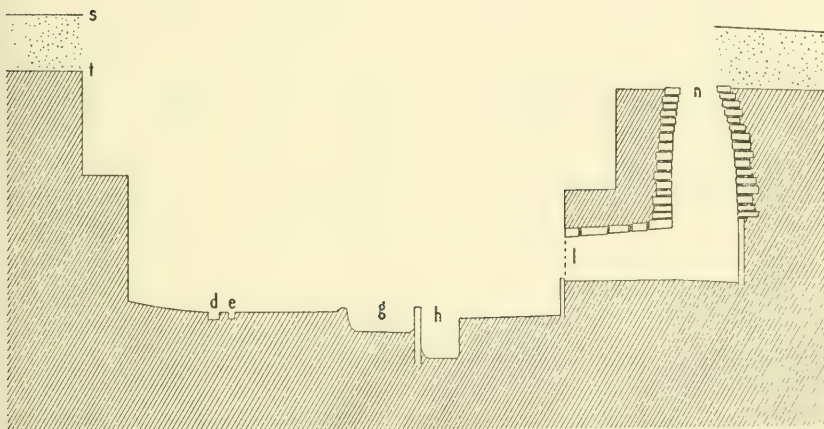
FIGURE 45.—Kiva A. *a*, holes for roof supports; *b*, storage pit; *c*, storage hole; *d* and *e*, sipapus; *f*, plaster ridge on floor; *g*, fire pit; *h*, old ladder pit; *i*, ladder pole depressions; *j*, storage pocket; *k*, pot rest or storage pocket; *l*, ventilator aperture; *m*, poles reinforcing ventilator opening; *n*, ventilator shaft; *o*, slanting timber placements; *p*, *q*, *r*, storage pockets on bench top; *s*, present surface; *t*, old ground level.

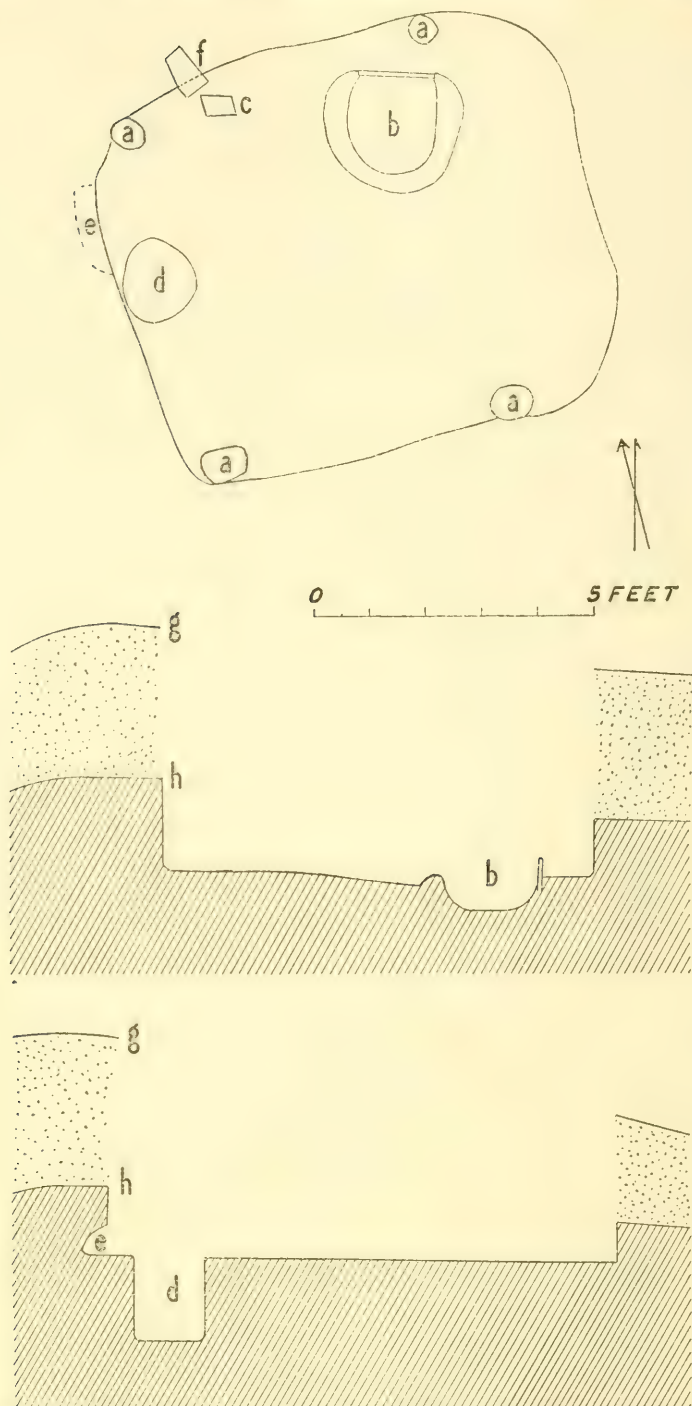
FIGURE 46.—Brush shelter. *a*, holes for roof supports; *b*, fire pit; *c*, stone step; *d*, storage pit in floor; *e*, subwall pocket; *f*, stone tread; *g*, present surface; *h*, old ground level.

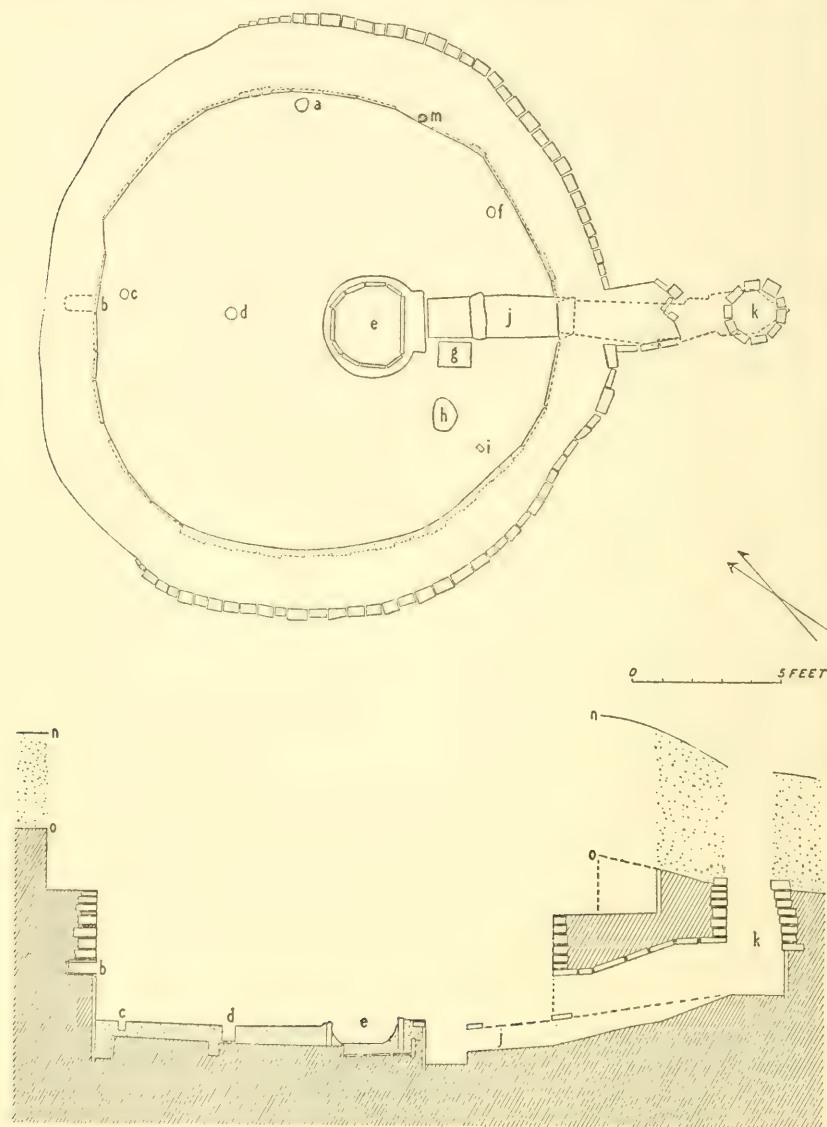
FIGURE 47.—Kiva B, upper floor level. *a*, storage hole in floor; *b*, Katsina niche; *c*, storage hole in floor; *d*, sipapu; *e*, fire pit; *f*, storage hole; *g*, ash pit; *h*, stone in floor; *i*, stone in floor; *j*, subfloor ventilator trench; *k*, ventilator shaft; *m*, post incorporated in bench; *n*, present ground level; *o*, original surface.

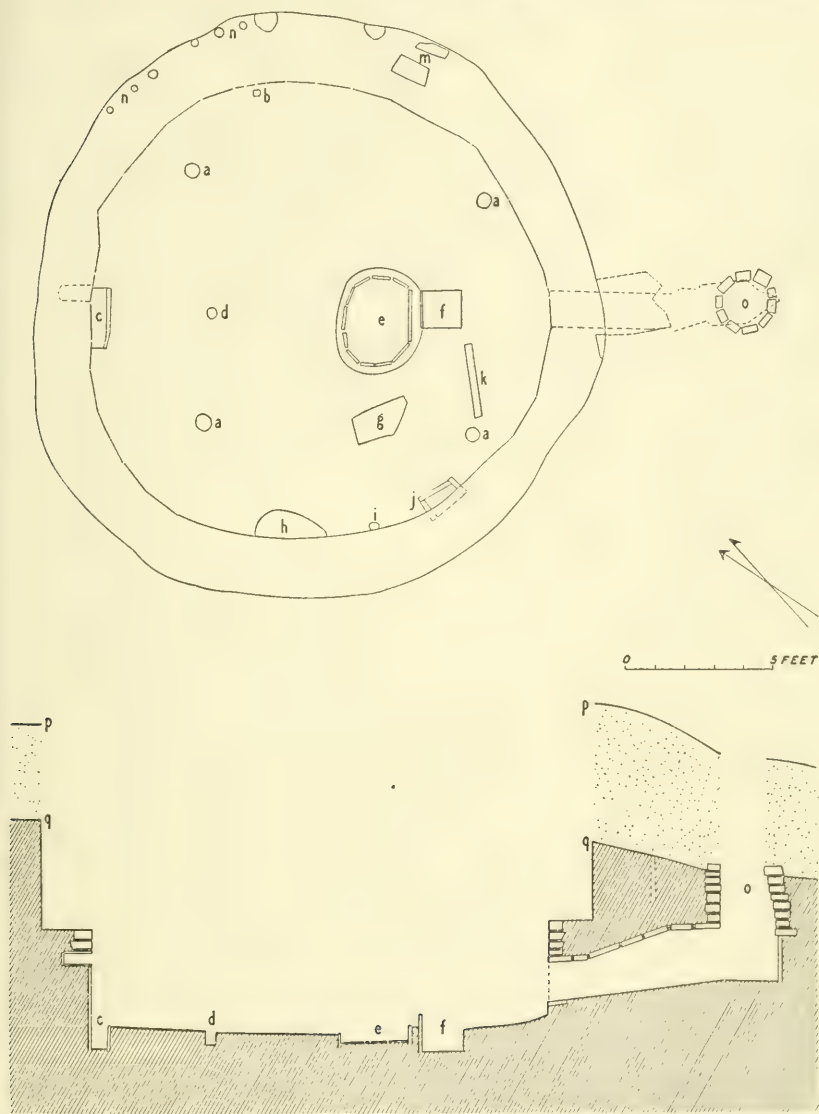
FIGURE 48.—Kiva B, original floor level. *a*, holes for main roof posts; *b*, stone in floor; *c*, storage box; *d*, sipapu; *e*, fire pit; *f*, ladder box; *g*, stone embedded in floor; *h*, storage pit; *i*, storage hole; *j*, subwall storage box; *k*, stone in floor; *m*, stones embedded on bench top; *n*, holes for slanting side poles; *o*, ventilator shaft; *p*, present ground level; *q*, original surface.

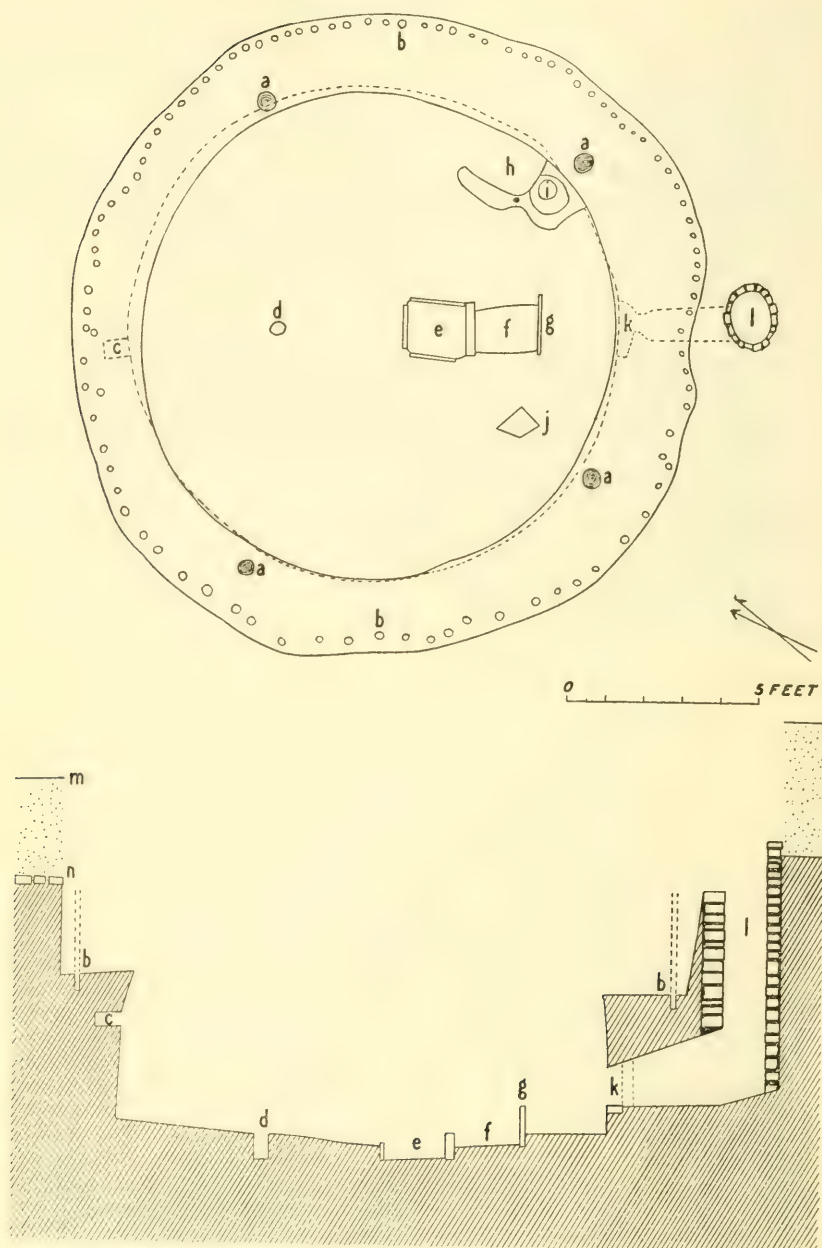
FIGURE 51.—Kiva for unit No. 3. *a*, posts incorporated in bench to reinforce wall; *b*, holes for poles forming wainscoting; *c*, Katsina niche; *d*, sipapu; *e*, fire pit; *f*, ash pit and ladder box; *g*, deflector; *h*, shallow basin in floor; *i*, small circular basin with stone bottom; *j*, stone embedded in floor; *k*, ventilator opening; *l*, ventilator shaft; *m*, present surface; *n*, old ground level.

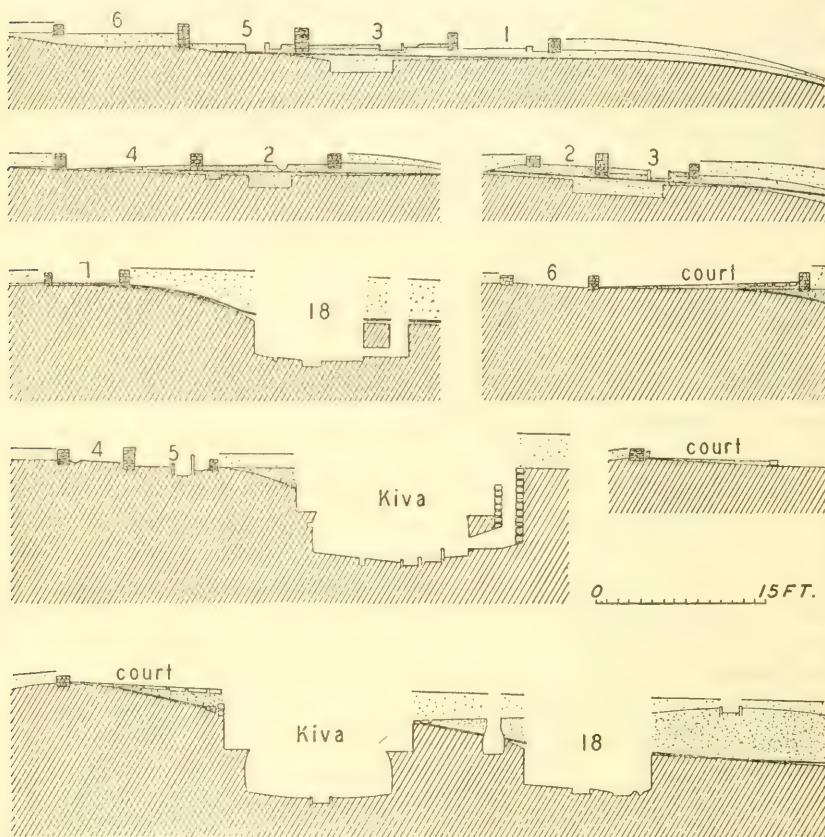
FIGURE 52.—Sections in third unit. Heavy line passing through fill indicates layer of red earth separating occupation level of pit structure and that of subsequent unit.
